NASA CR-54323  
EOS REPORT 4920-Final

# ION ROCKET SYSTEM RESEARCH AND DEVELOPMENT

NATIONAL AERONAUTICS AND SPACE ADMINISTRATION

**ELECTRO-OPTICAL SYSTEMS, INC.,** Pasadena, California  
A Subsidiary of Xerox Corporation

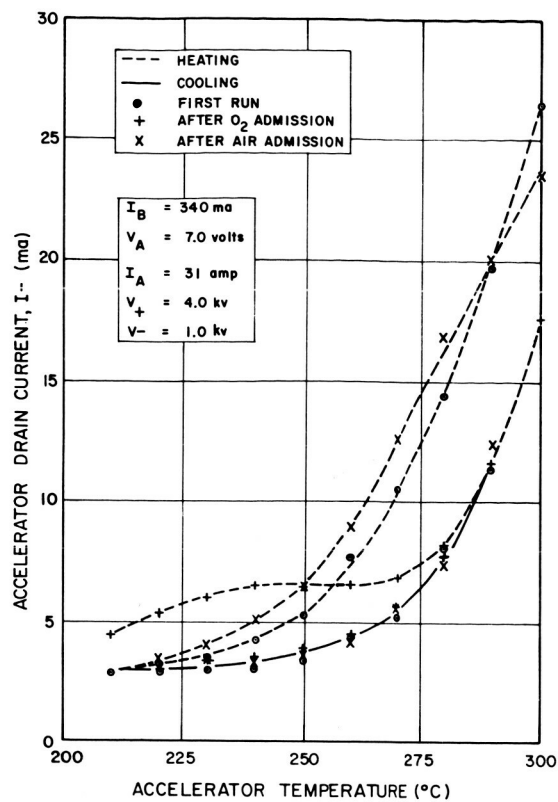
The data obtained are shown by the circled data points in Fig. 3. The apparent hystereses in the data are probably due to slow changes in the equilibrium surface conditions on the accelerator and to a temperature difference between the emissive surface and the point at which the thermocouple was attached. The length of the support arm coupled with the heat capacity of the support insulator and shield should cause the measured temperature to lag the temperature of the electrode proper. A very strong temperature dependence is shown by the data of Fig. 3.

FIG. 3  
TEMPERATURE AND OXYGEN  
DEPENDENCE OF DRAIN  
CURRENT

After returning to the original operating level, oxygen was admitted to the vacuum system until the pressure had risen from about  $10^{-6}$  torr to  $10^{-5}$  torr. A slight increase in drain current was noted as the pressure increased. When the pressure reached  $10^{-5}$  torr, the bleed valve was closed and a sharp rise in drain current was observed. The system was allowed to regain the initial conditions and the heating and cooling test was repeated. The data obtained are shown by the crossed data points (+) in Fig. 3. These data show a significant increase in the drain current during the early portion of the heating cycle with no hysteresis apparent in the higher temperature data. The oxygen admission had apparently increased the electron emission at the lower temperatures. The heating above 270°C, however, seems to have returned the electrode to its original surface condition.

A third set of data was taken after air was admitted to the vacuum system in a manner similar to the previous admission of oxygen. These data are shown by the X's in Fig. 3. This curve is quite similar to the curve obtained during the first run and indicates that the electrode surface had indeed been returned to its initial condition.

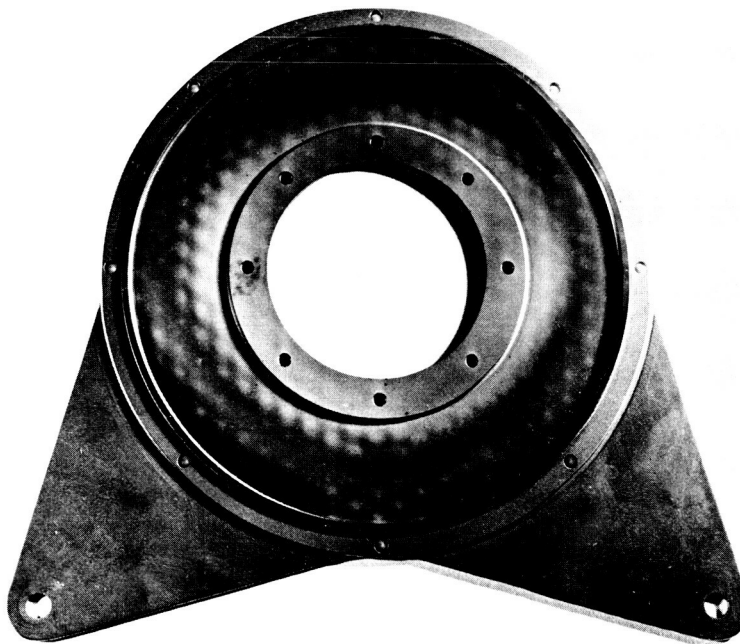
FIG. 4  
CATHODE MOUNTING PLATE  
AFTER HIGH DRAIN TEST

During all three tests, significant increases in cathode temperatures were measured when the drain current was high. At times, drain currents higher than 50 mA were observed. Upon disassembly of the engine, a pattern of "clean" spots was observable on the cathode plate which closely matched the electrode pattern. A photograph of this cathode plate is shown in Fig. 4. These spots are considered to be due to electrons accelerated across the electrode gap and through the screen apertures.

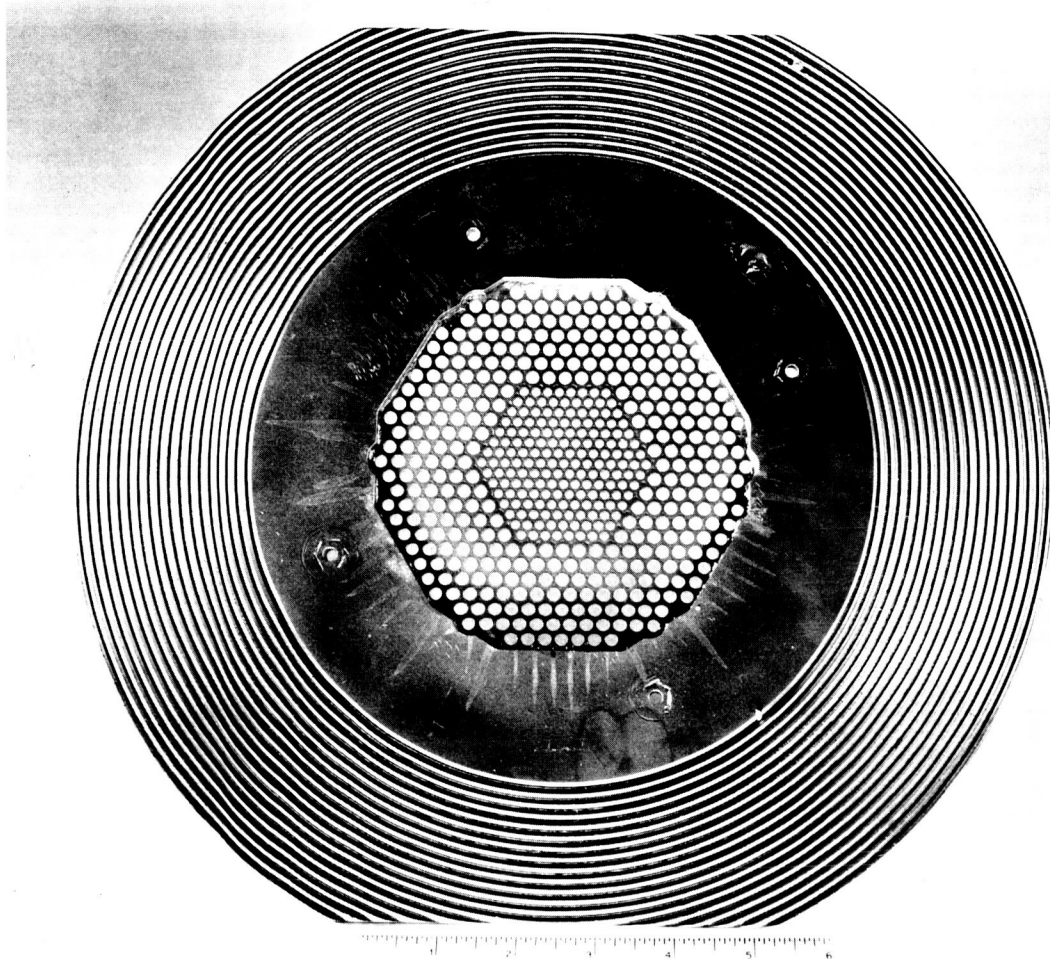
FIG. 5 COOLED-COPPER ACCELERATOR ELECTRODE AFTER 57-HOUR TEST

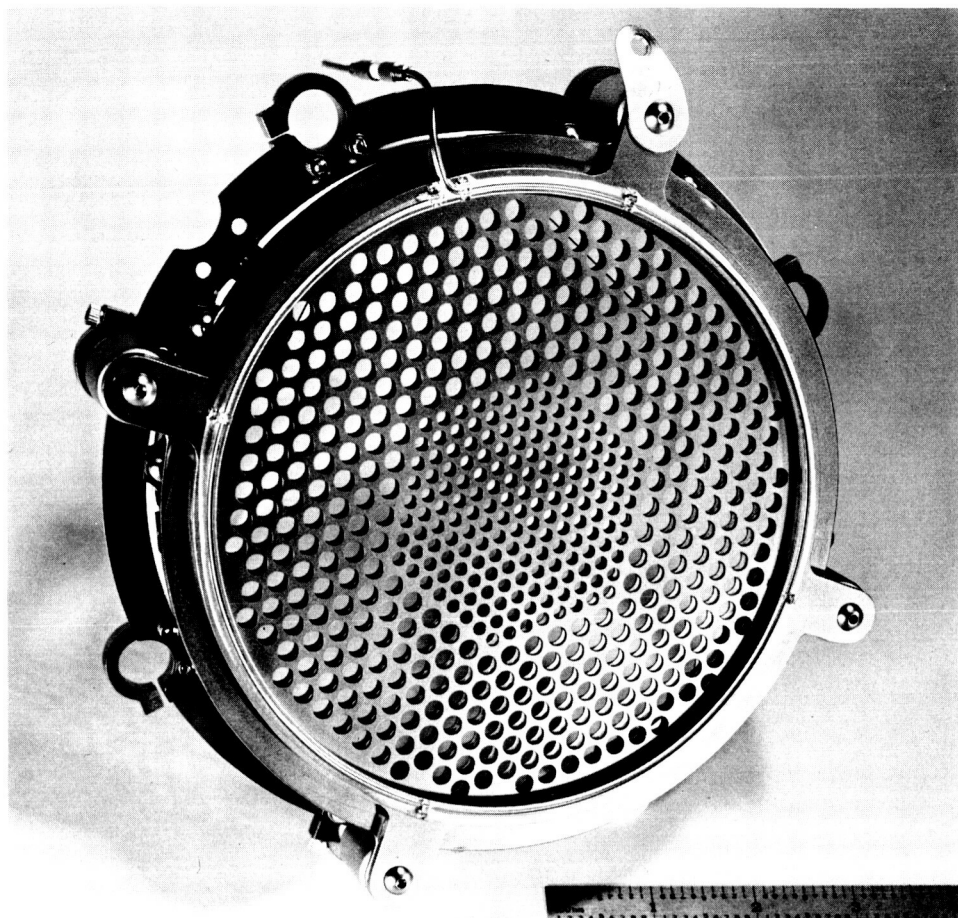
FIG. 6 HEATER RING CLAMPED ON ELECTRODE ASSEMBLY

in brazing heaters to all of the materials tested, a separate heater ring was designed for use with the other electrodes. A stainless steel ring was fabricated and a heater brazed in a groove cut in the ring. This ring was used to heat the electrodes being tested for electron emission characteristics. Figure 6 shows an accelerator electrode assembly with the heater ring installed. The ring is clamped to the electrode with the brazed side facing downstream. This procedure was adequate for the testing undertaken. Electrode temperatures could be raised a hundred degrees centigrade or more over normal operating temperature.

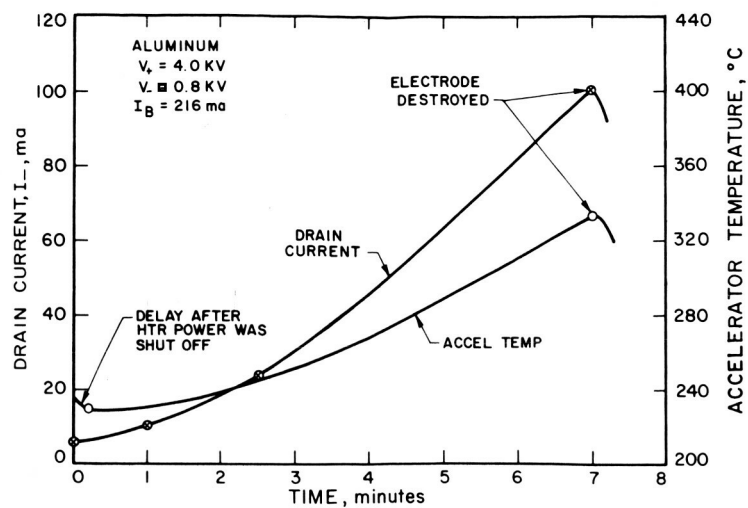
FIG. 10 ALUMINUM ELECTRODE CURRENT AND TEMPERATURE AT TIME OF DESTRUCTION

When the arc power circuit had been repaired, an attempt was made to restart the engine and repeat the test. The start went smoothly until a beam level of approximately 200 mA was reached. At this point severe arcing between electrodes occurred and the drain current began to rise. As viewed through a vacuum chamber window the electrode appeared to be severely bowed in the downstream direction. Heating power to the electrode (used in starting to provide smoother and more rapid starts) was immediately shut down. The electrode had by this time reached a temperature of approximately 270°C. The drain current continued to rise and it was impossible to obtain more than 250 mA of beam current. Electrode temperature rose steadily with the drain current (Fig. 10) until local heating melted a large hole in the aluminum grid. The test was terminated at this point.

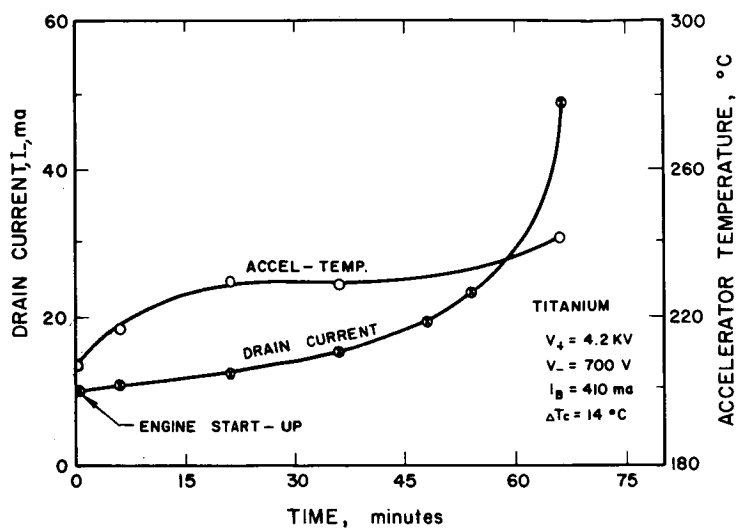
FIG. 12  
ELECTRODE TEMPERATURE AND  
DRAIN CURRENT VERSUS TIME  
FOR TITANIUM

The drain current was not stable at these conditions and immediately went into a runaway condition. A time profile of accelerator temperature and drain current variations during this runaway condition is shown in Fig. 12.

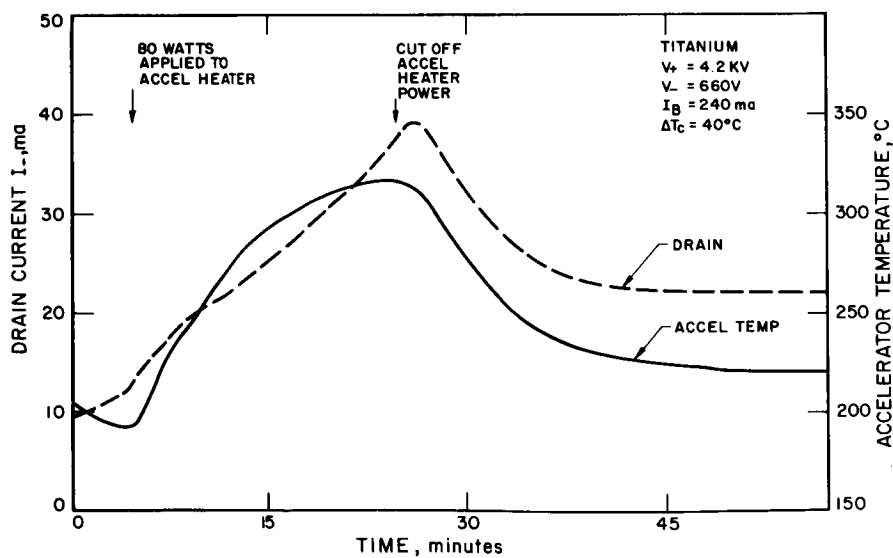
FIG. 13 ELECTRODE TEMPERATURE AND DRAIN  
CURRENT VERSUS TIME FOR TITANIUM  
ELECTRODE AT REDUCED BEAM LEVEL

as a function of accelerator temperature. Data from this test are shown in Fig. 13. It should be noted that although reducing the beam level lowered the drain current from the high level attained during runaway at full beam, the drain again began to increase immediately. When the accelerator temperature had dropped to  $191^{\circ}\text{C}$ , 80 watts of heater power were applied to the accelerating electrode. Both drain current and accelerator temperature rose steadily as shown. When it became obvious that the drain current was not going to stabilize, the accelerator heating power was turned off. The drain current leveled at 22 mA and the accelerator temperature at  $220^{\circ}\text{C}$ .

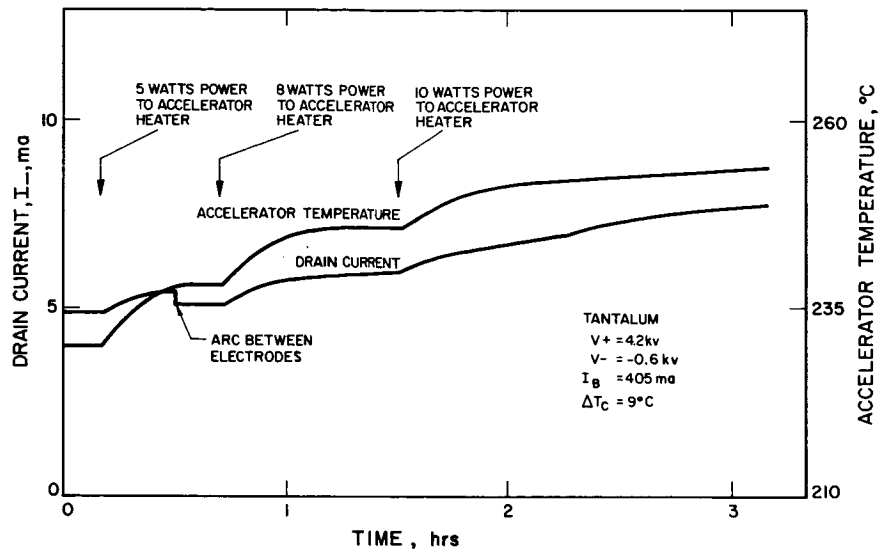
FIG. 16 ACCELERATOR TEMPERATURE AND DRAIN CURRENT VERSUS TIME FOR TANTALUM ELECTRODE HEATING TEST

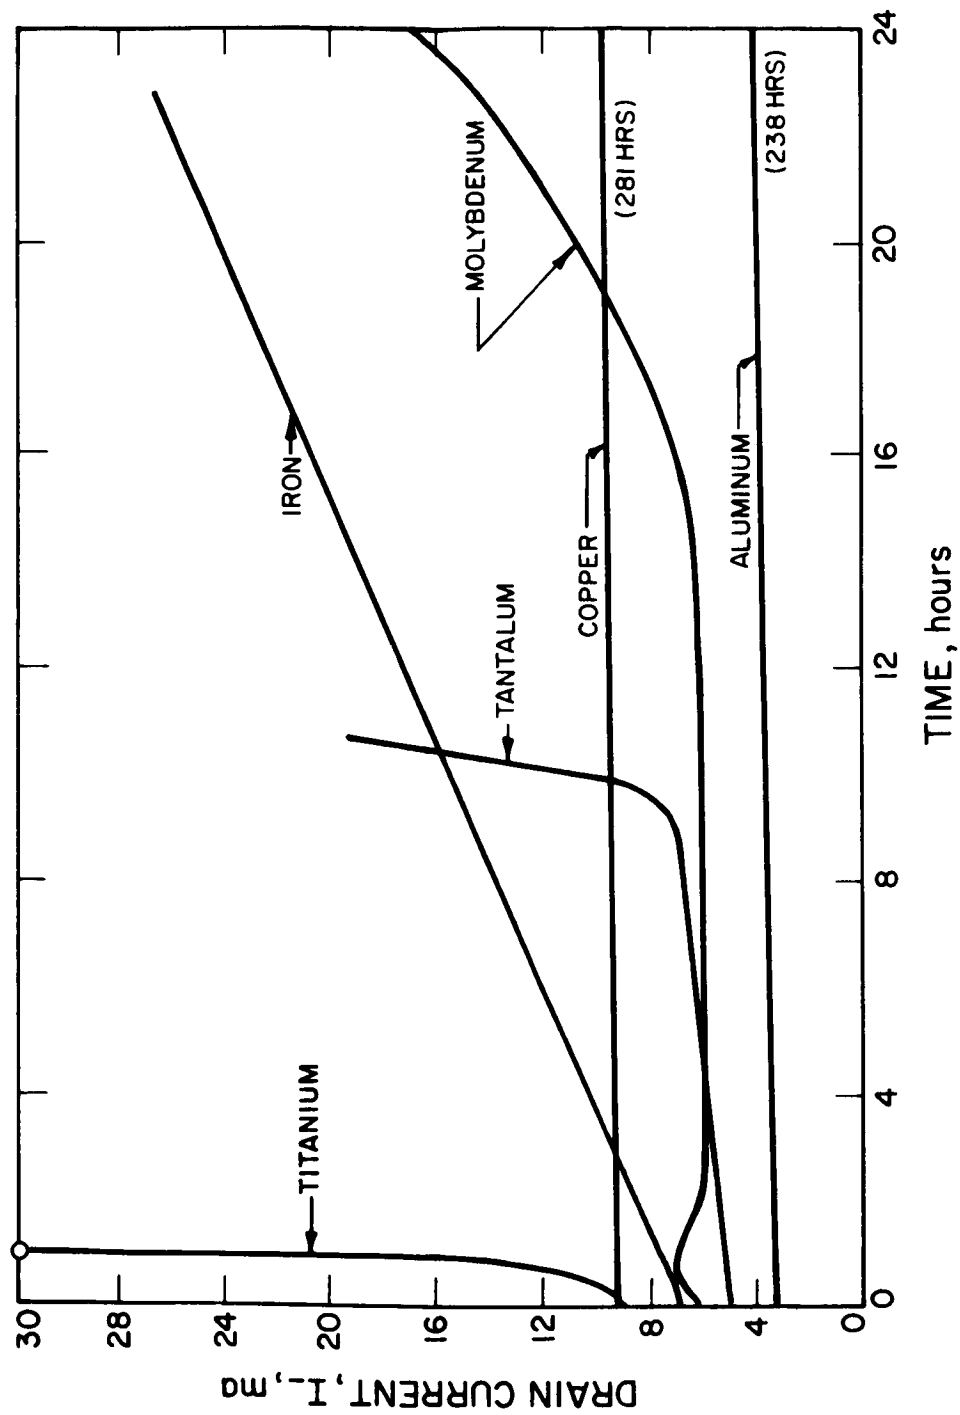
FIG. 18 EXTENDED TESTS WITH VARIOUS ELECTRODE MATERIALS

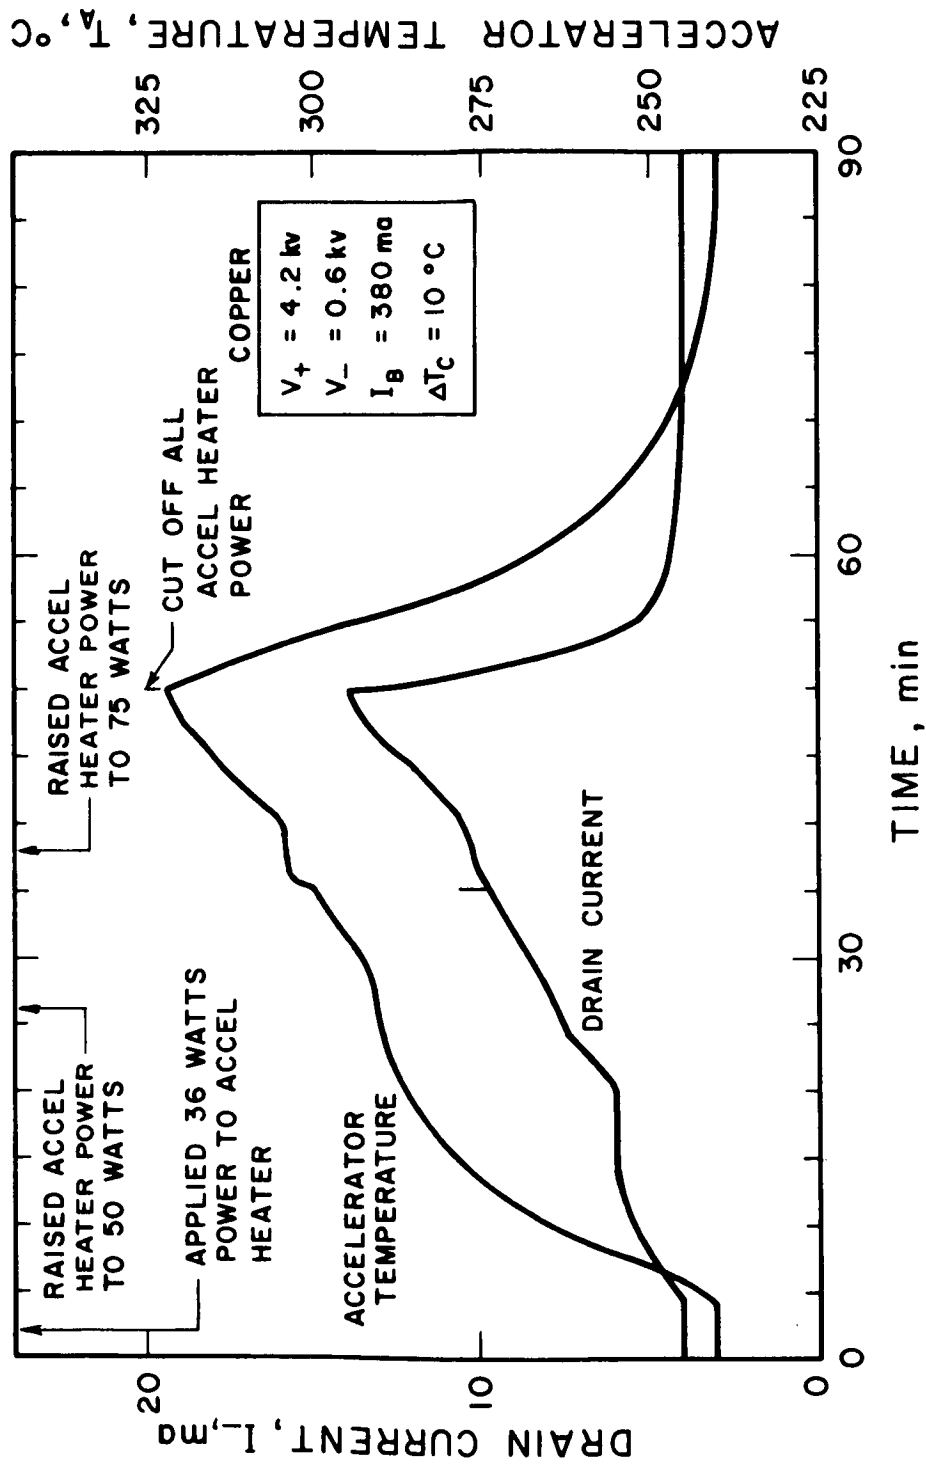
FIG. 19 ACCELERATOR TEMPERATURE AND DRAIN CURRENT VERSUS TIME FOR COPPER ACCELERATING ELECTRODE

Power was applied to the accelerating electrode heater in increments and the behavior of the electrode temperature and drain current was as shown in Fig. 19. The drain current was observed to increase with increasing accelerator temperature. At the maximum temperature attained, 322°C, the drain current was 13.9 mA. During the time these changes took place, the cathode housing temperature also increased by 10°C.

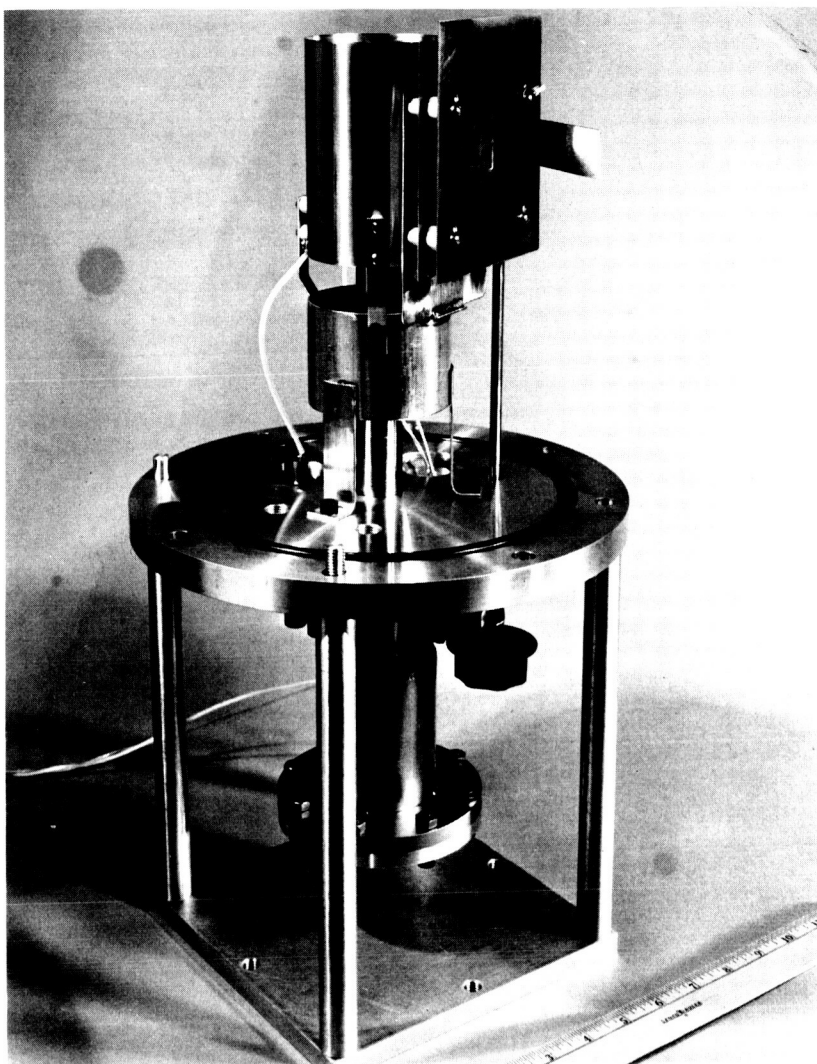
FIG. 21 ASSEMBLED SPUTTERING APPARATUS

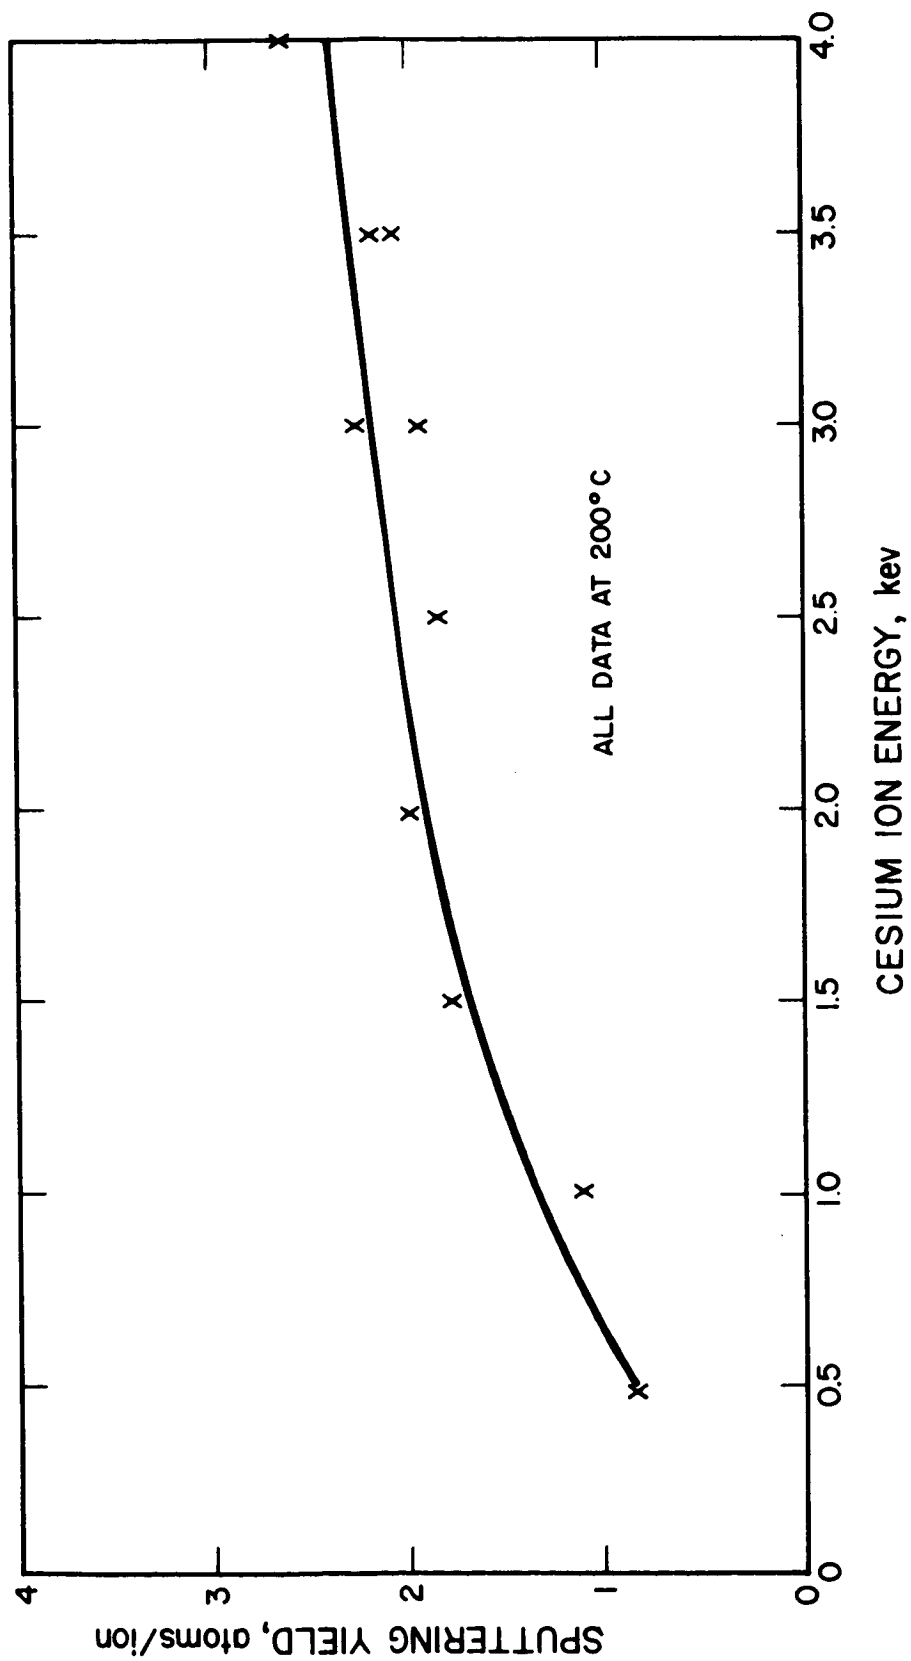
FIG. 22 SPUTTERING YIELD OF ALUMINUM VERSUS BOMBARDING CESIUM ION ENERGY

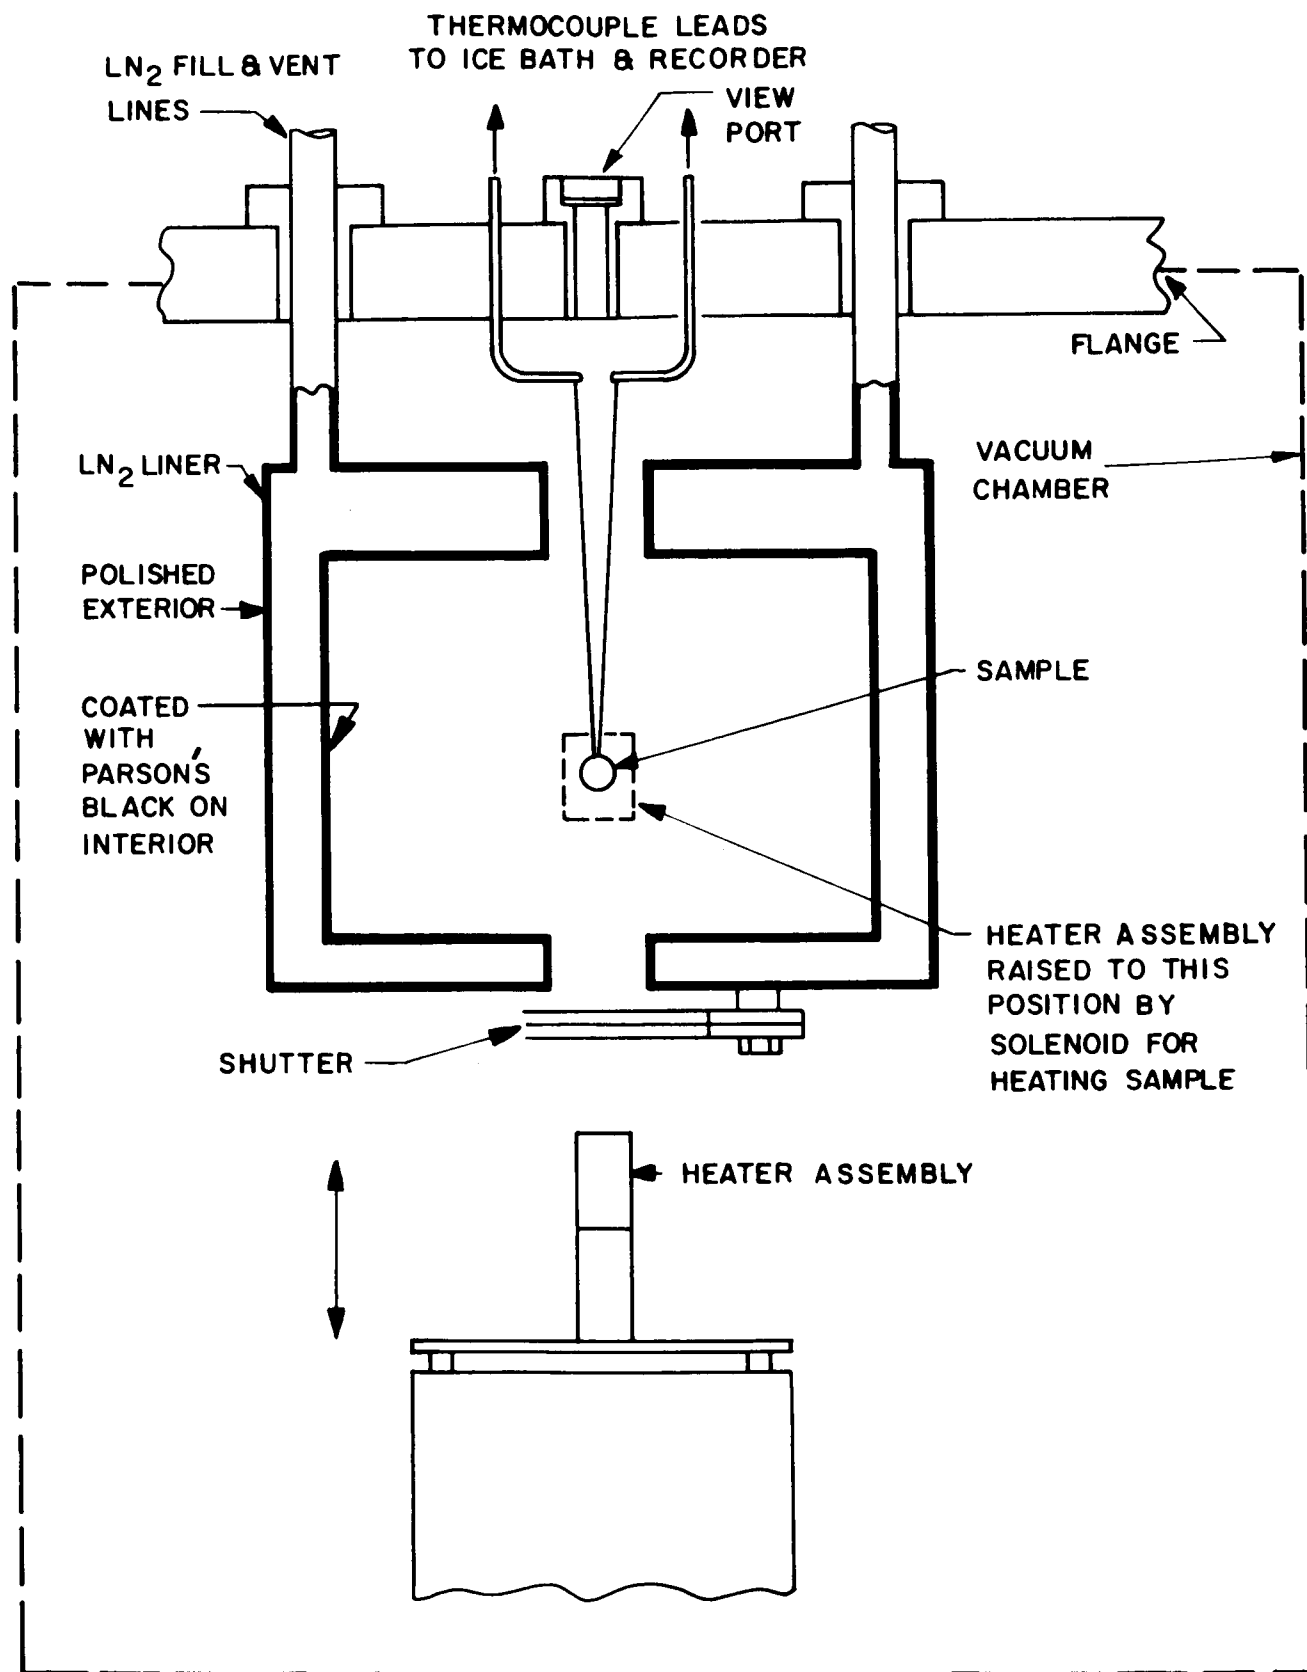
FIG. 23 SCHEMATIC OF APPARATUS FOR EMITTANCE MEASUREMENTS BY THE FREE COOLING TECHNIQUE

The samples were then mounted in the emittance apparatus as shown in Fig. 23. The nominal sample size was 0.250-inch diameter by 0.040-inch thick. The chromel-constantan thermocouples were 0.003-inch

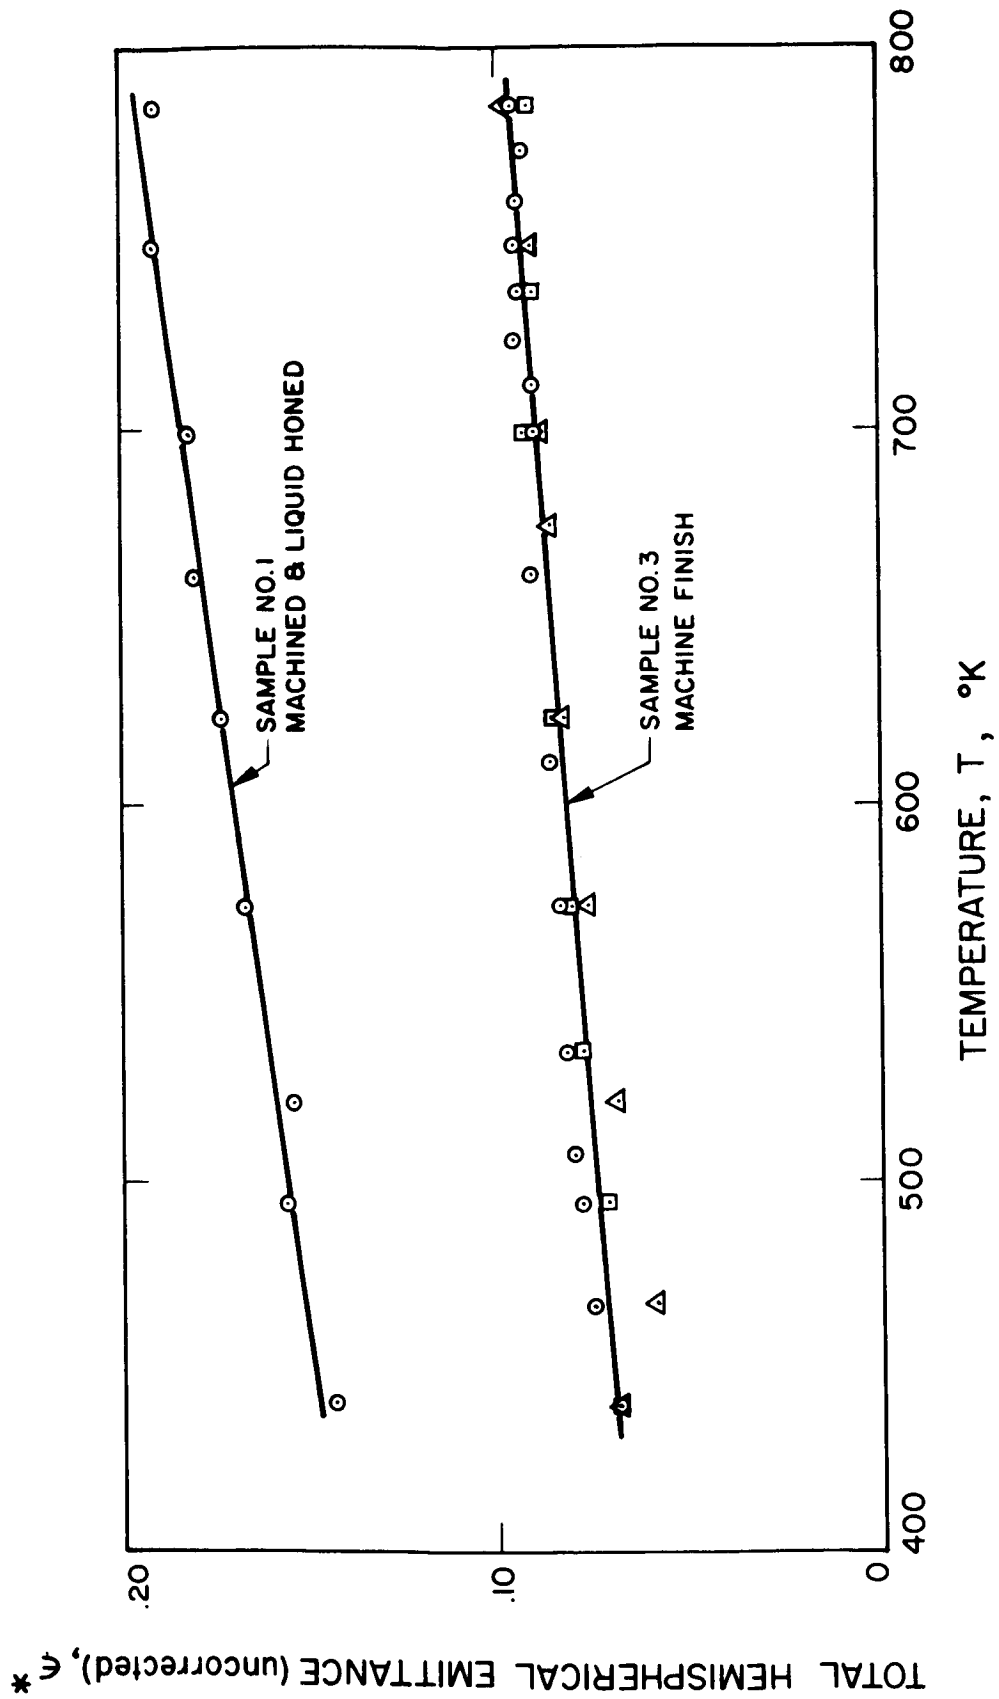
FIG. 24 ALUMINUM EMITTANCE MEASUREMENTS

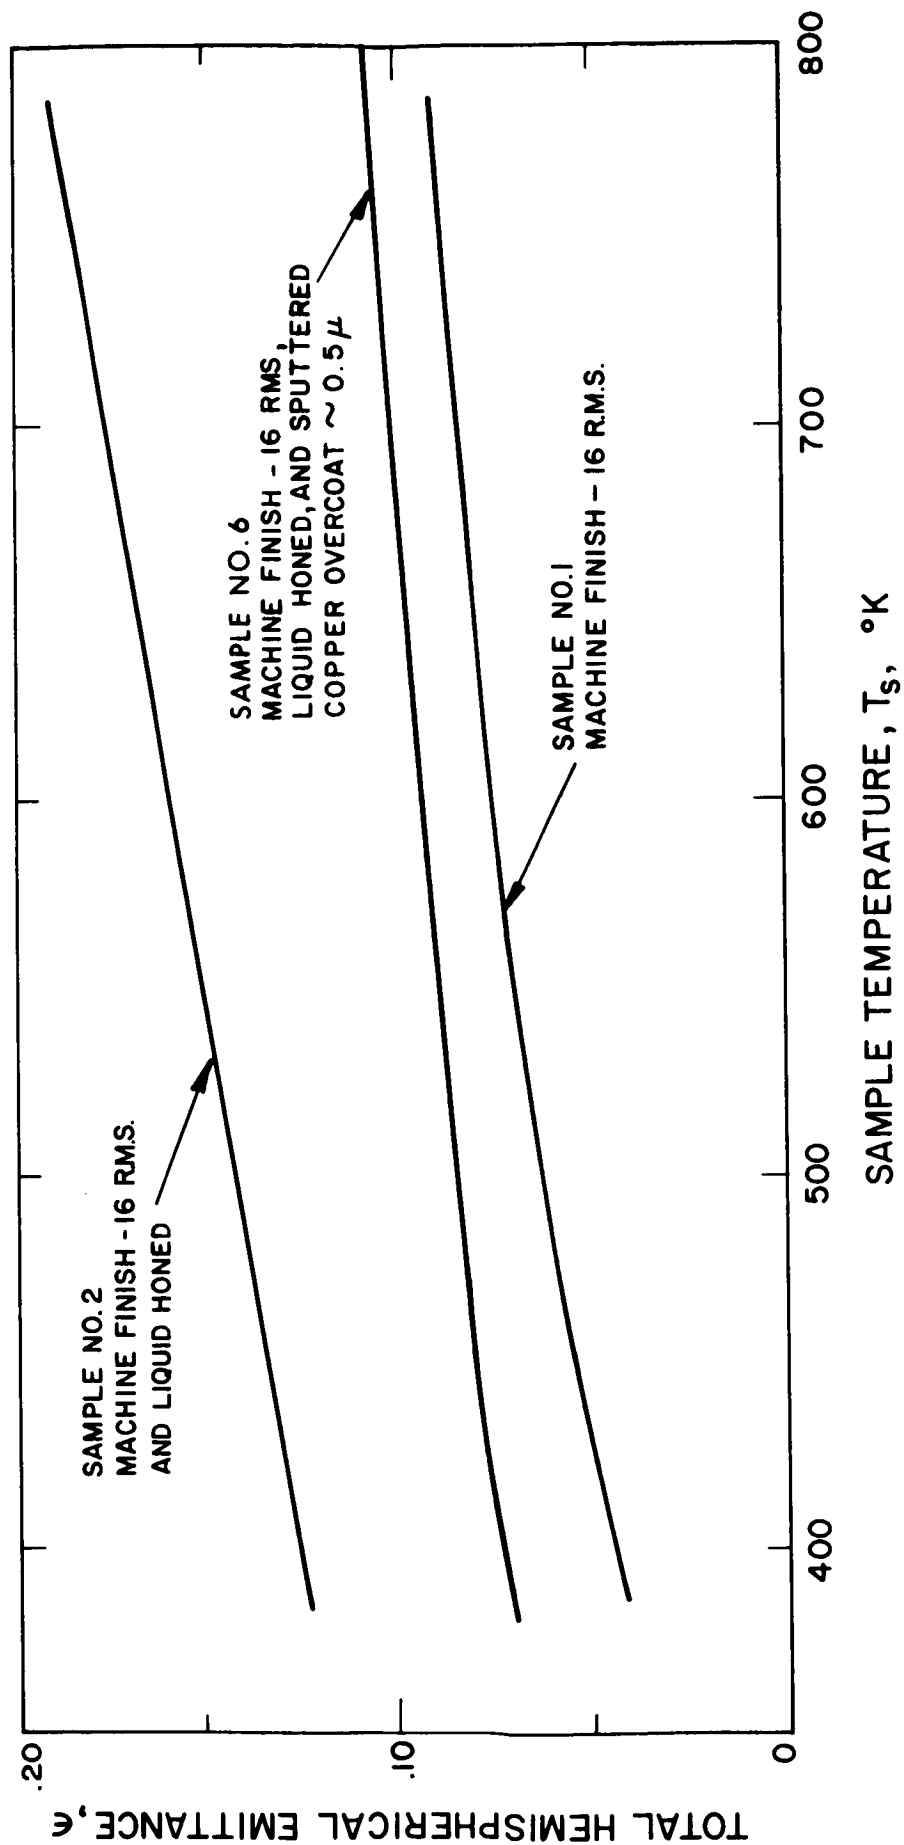
FIG. 25 EMISSANCE VERSUS TEMPERATURE FOR SEVERAL SURFACE CONDITIONS OF ALUMINUM SAMPLES

The general trends appear to be that liquid honing approximately doubles the emittance of as-machined 1100H14 aluminum alloy, and copper coating reduces it toward the original as-machined condition.

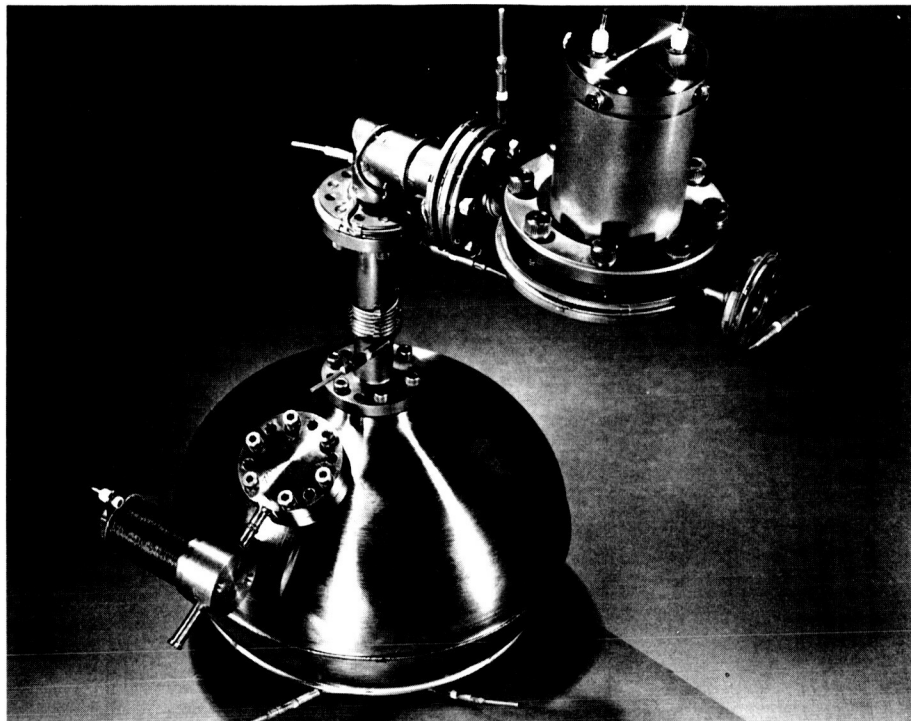
FIG. 26 750-HOUR FEED SYSTEM AND SOLENOID-OPERATED  
FEED VALVE

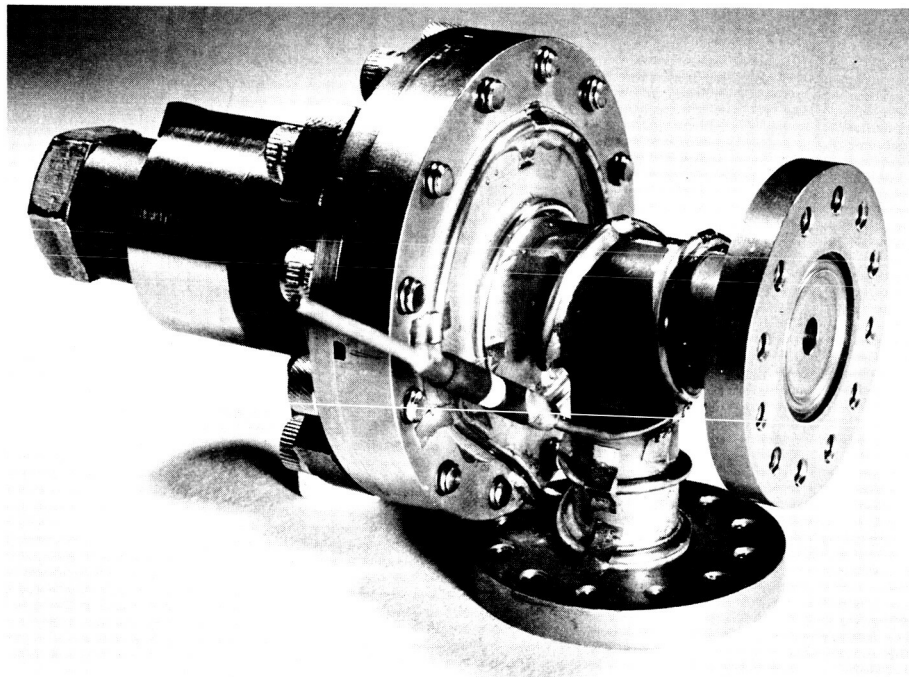
FIG. 28 MANUAL VALVE

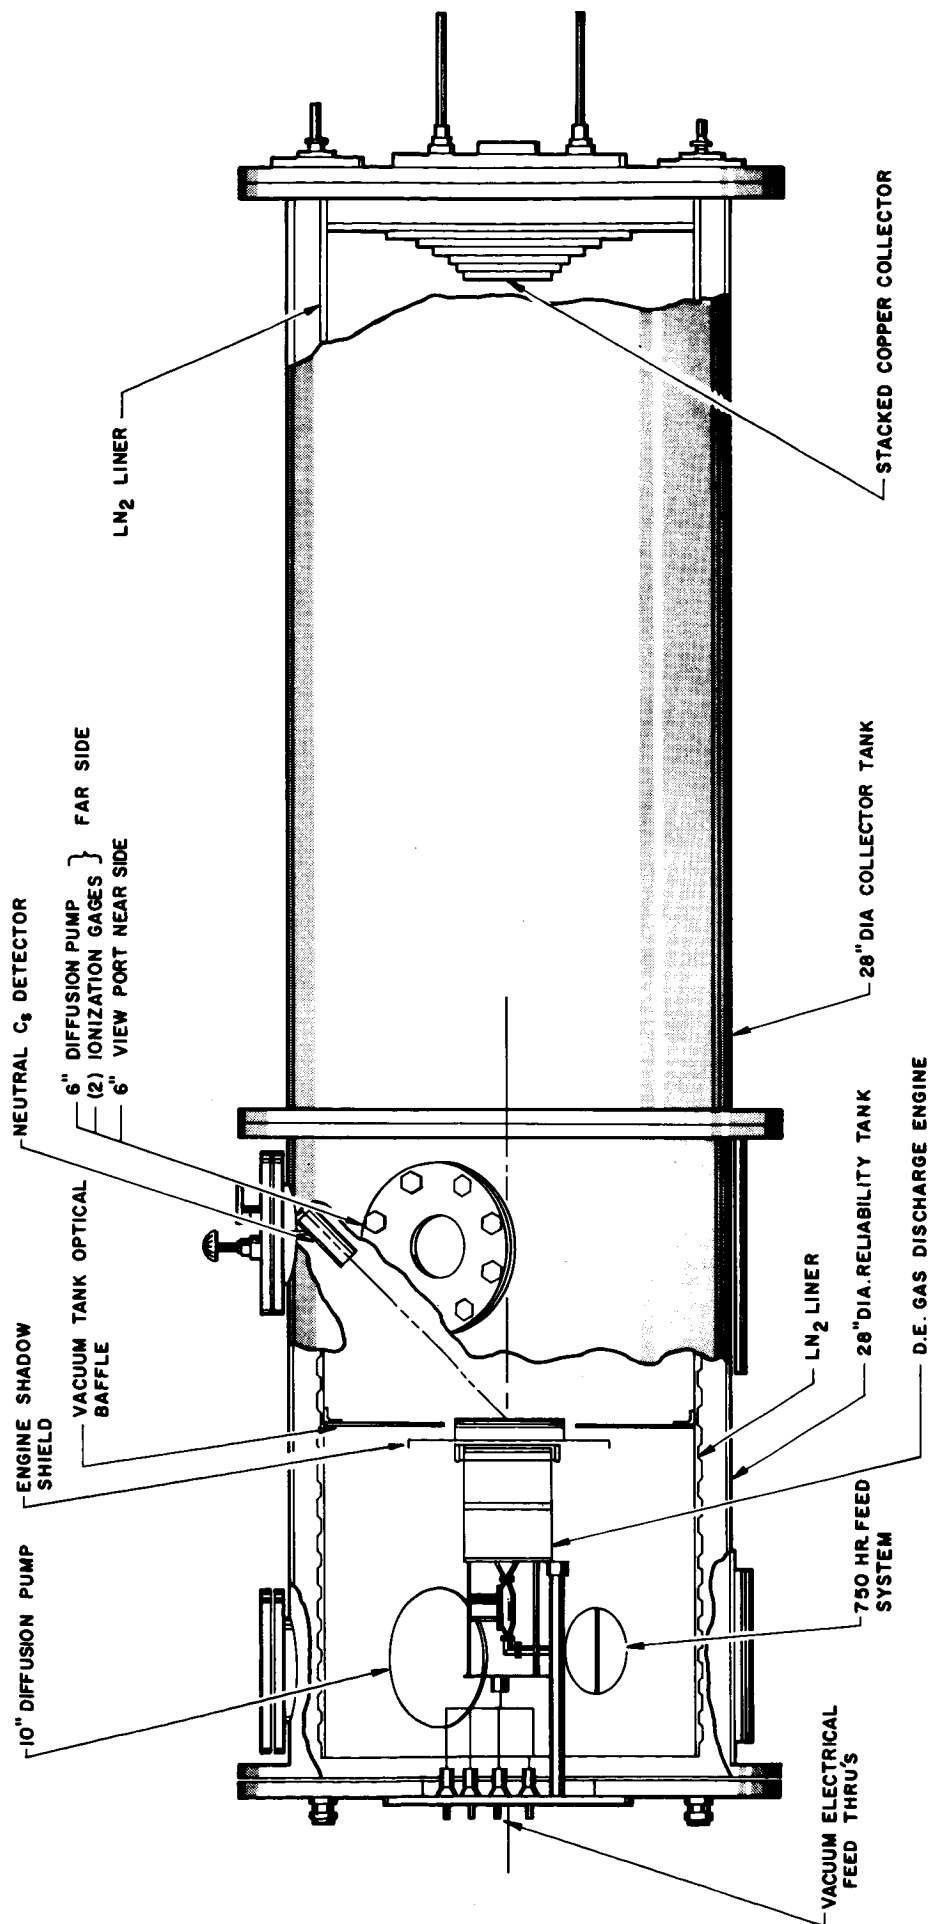
FIG. 30 FACILITY FOR EXTENDED TESTS OF THE DE ENGINE SYSTEM

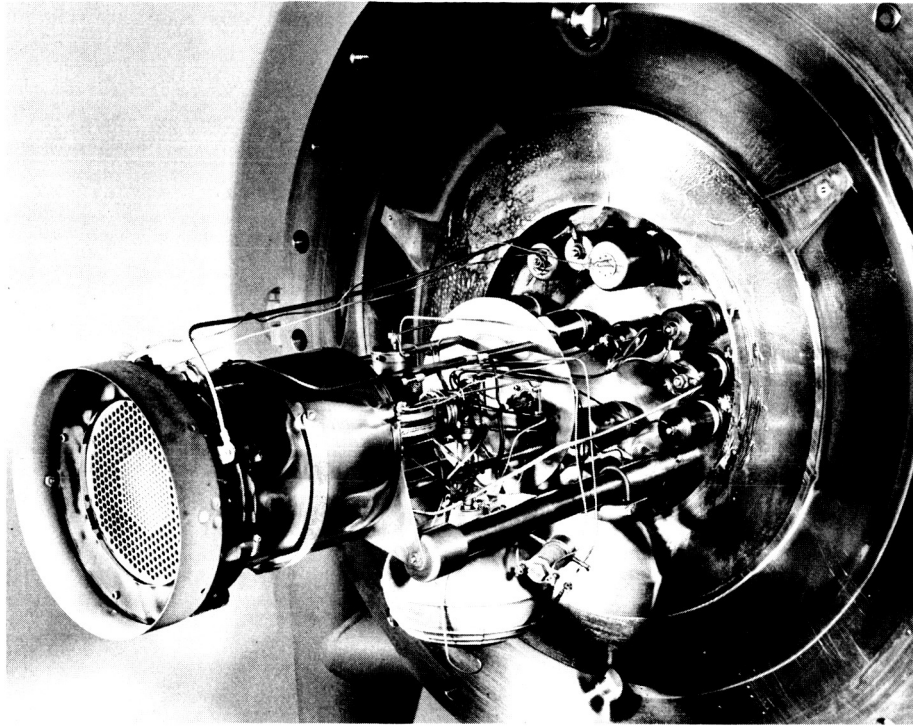
FIG. 37 DER-1 ENGINE SYSTEM AFTER 281-HOUR TEST

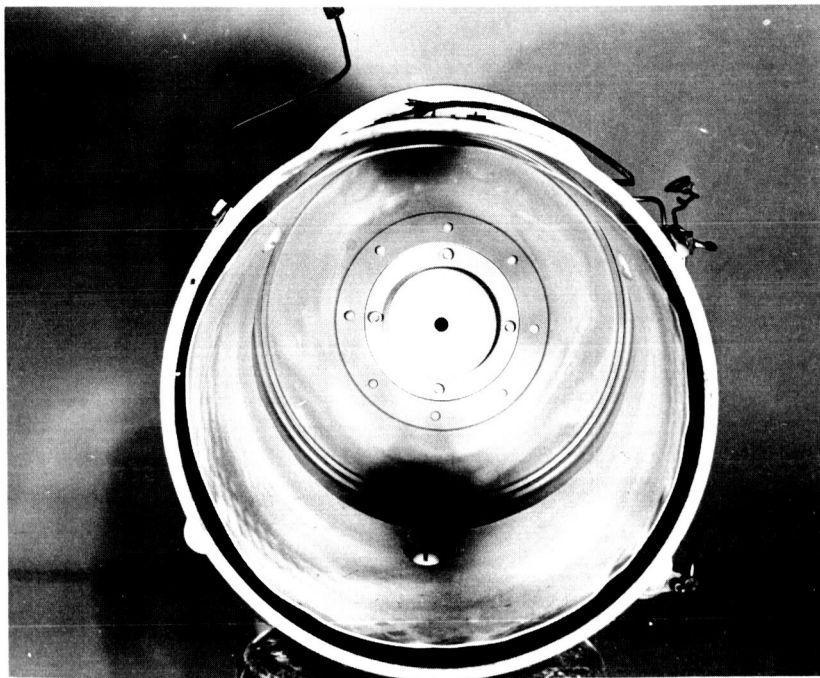
FIG. 39 ANODE AND CHAMBER INTERIOR

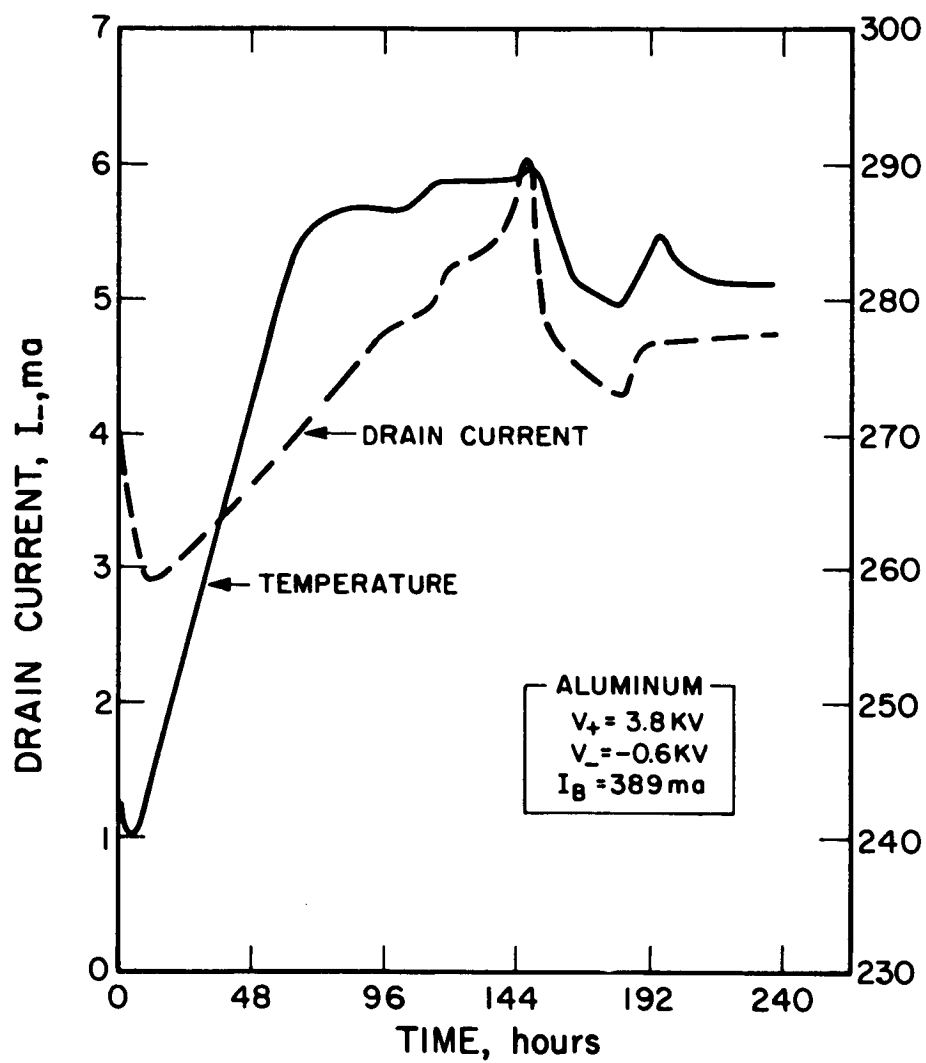
FIG. 51 DRAIN CURRENT VERSUS TIME PROFILE FOR 238-HOUR ALUMINUM ELECTRODE TEST
